Advanced Ultrasonic application for the inspection of turbine components

Hans RAUSCHENBACH,
Michael CLOSSEN- VON LANKEN SCHULZ,
Dr. Michael OPHEYS, Michael SIEGEL, Siemens Energy Sector

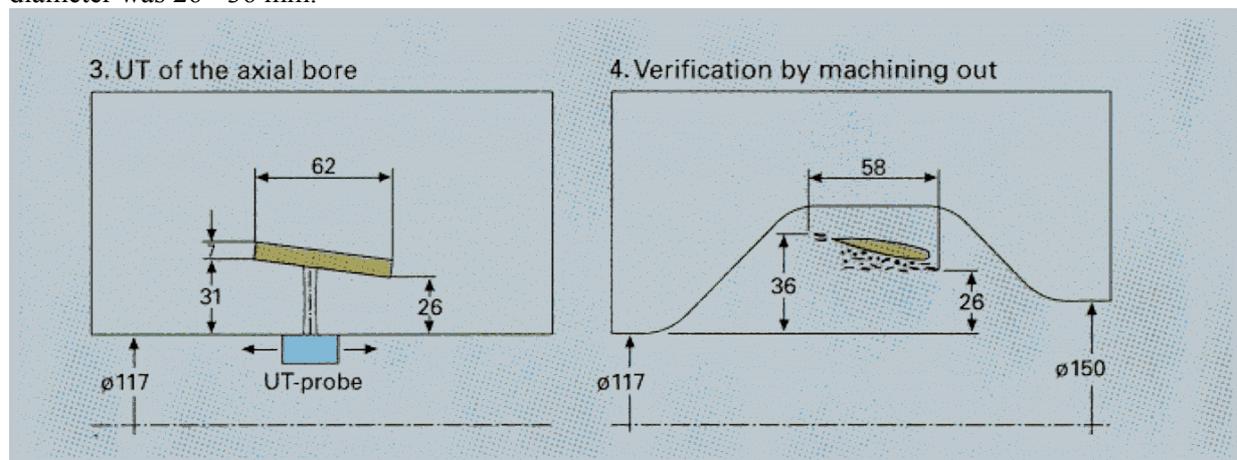
A single indication (equivalent to a circular reflector size 5.5 mm in diameter) was identified in the gland area during ultrasonic volumetric examination from the outside surface of an HP turbine shaft of Russian design (LMZ). This indication was located approximately 26 mm from the surface of the through axial bore. No indications were identified during surface crack testing of the axial bore. Ultrasonic examination from the axial bore confirmed the indication detected from the outside. An angular oriented indication (26-31 mm from the bore surface) approximately 62 mm long was identified. Analysis of the recorded echo dynamics enabled a radial extension of 7 mm to be determined. Figure 19 shows the results of the ultrasonic volumetric examination (from the outside surface) and the ultrasonic examination from the bore.

Fracture-mechanics analysis of this flaw led to the assessment that the flaw was unallowable in terms of safe and reliable continued operation of the turbine shaft.

Assessment of all examinations carried out (step-by-step machining-away of the indication area was carried out in 2.5 mm stages, with an MP examination carried out after each stage) showed that the total axial extension of the tube-type forging flaw was 58 mm, and the distance from the original bore diameter was 26 - 36 mm.

Fig 1
UT results of rotor bore inspection of axial bore of the HP rotor

Fig. 2
Shape of the axial bore after machining the findings (true length of flaw: 58 mm)

It was decided to machine away the flaw area in stages while carrying out a surface crack examination (MP examination) to determine the actual flaw size.

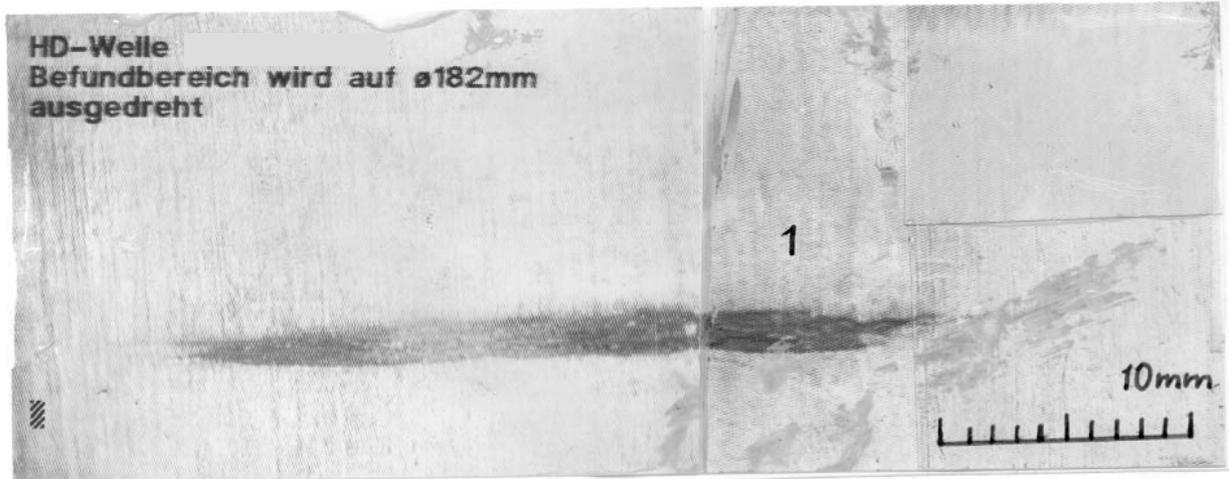
Fig 3

The indication was exposed at a depth of 31 mm from the original bore diameter. Figure 21 shows that the indication exhibited an axial extension of approximately 38 mm at this depth.

Result of MT inspection of the axial bore during machining of bore diameter

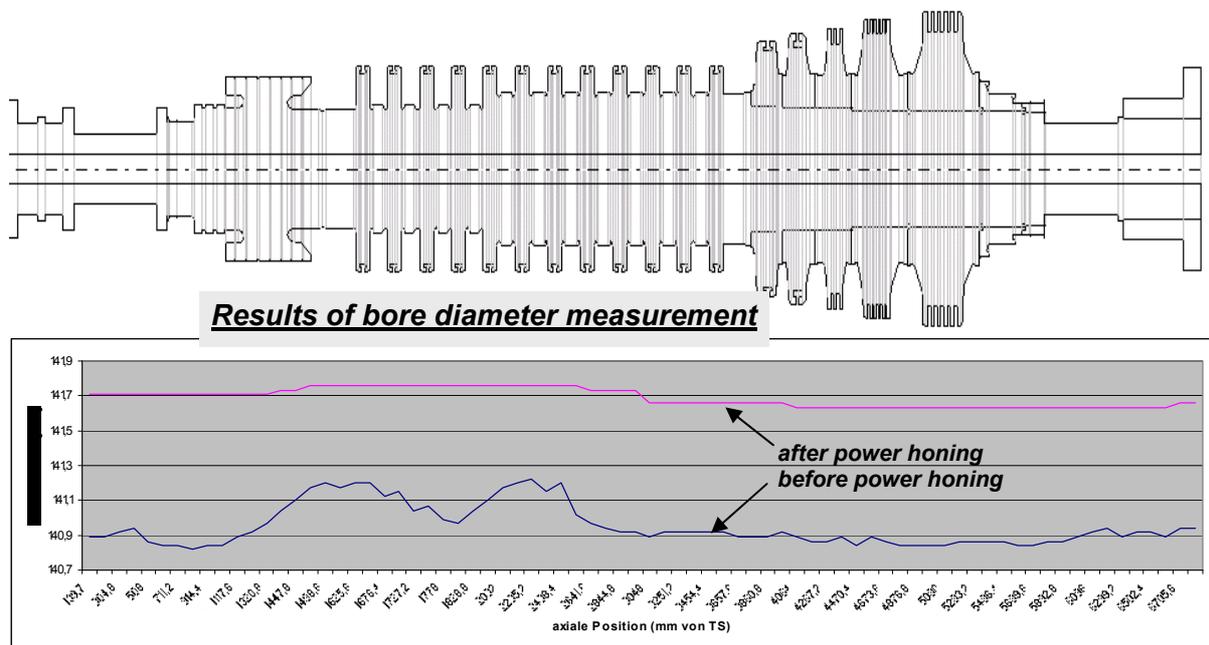
Measurement of the bore diameter over the entire length of the axial bore must be performed before honing of the bore surface in preparation for ultrasonic and eddy current bore examination (fine grinding of the surface to establish a high surface quality) in order to identify any creep damage in the area subjected to high heat loads. Fig. 4 shows the results of an inspection of an center bore in a 300 MW intermediate-pressure turbine shaft for creep damage. In this case, significant widening of the diameter of the axial bore was detected in the inlet area.

Fig. 4: Measurement of bore diameter for detection of creep damage

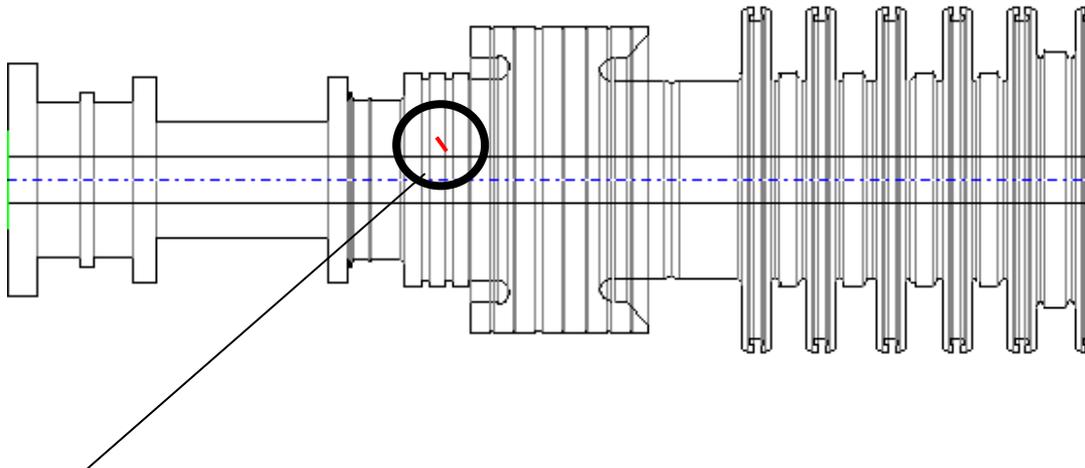
In both the UT and ET examination, an unusual indication (orientation in the circumferential direction) was detected in the area of the labyrinth piston with both the ET and UT examinations. The detected indication was an incipient crack in the circumferential direction which had already developed to an extent of 50% around the circumference of the bore surface. Ultrasonic examination revealed a crack depth of approx. 5 mm. The bore diameter was deliberately enlarged using the information from the nondestructive examinations so that the detected crack could be completely removed. The turbine shaft could be modified as planned in the turbine modification and returned to operation.

Fig. 5: crack detected on bore surface of an IP turbine shaft (NON Siemens design)

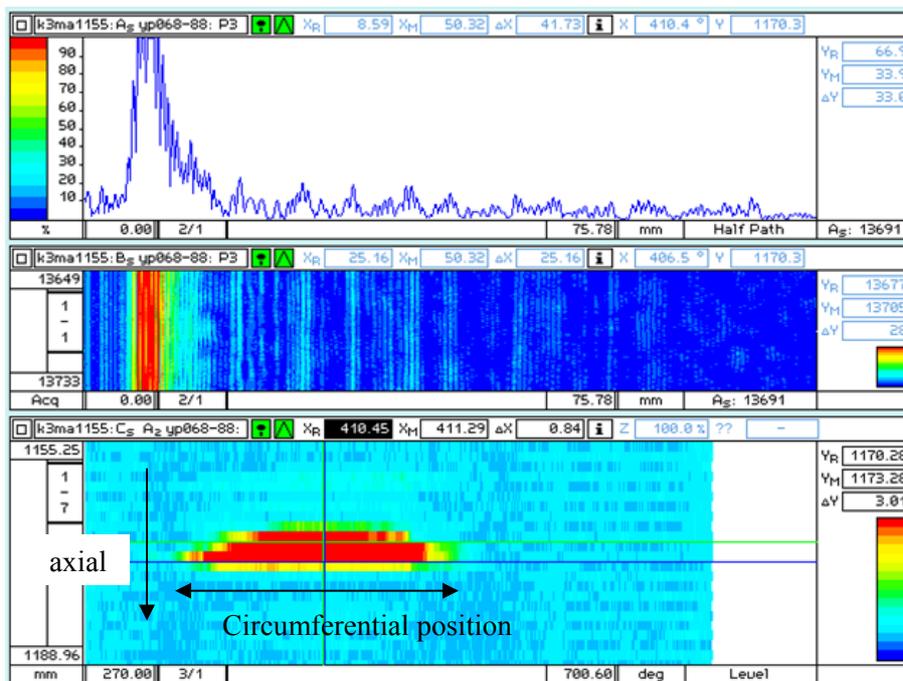
Fig. 6: UT results of bore examination (scanning direction from bore surface: axial/radial)

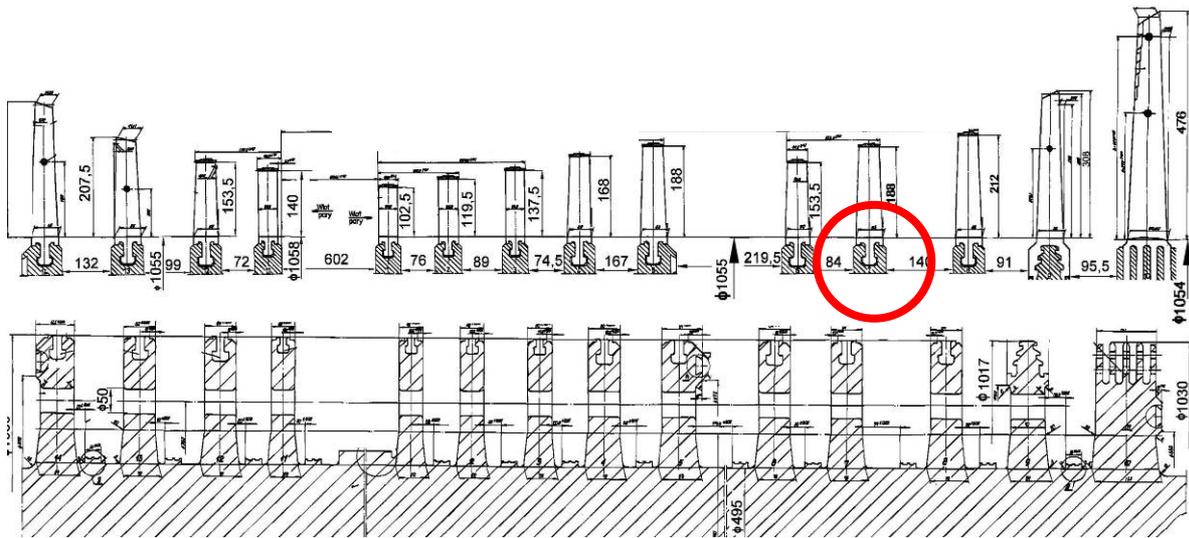
of stress corrosion cracking in the blade attachment groove for moving blade row 7 on the turbine shaft. It was then necessary to subject all turbine shafts of the same design to nondestructive examination in order to identify any similar damage to the blade attachment grooves of the HP/IP turbine shafts in a timely fashion.

Fig. 7: 110 MW HP/IP turbine shaft/blade grooves to be examined

The primary purpose of the project was the development of a phased-array ultrasonic examination method for blade grooves with the so-called "T-groove" design, as 12 of the 14 blade attachment grooves had this design. The grooves for blade rows 13 and 14 (so-called "fir-tree design" in row 13 and "radial entry pinned blade root design" in row 14) were examined by conventional examination methods. The groove for the blade row which resulted in damage due to stress corrosion cracking in 2004 is indicated in Fig. 7.

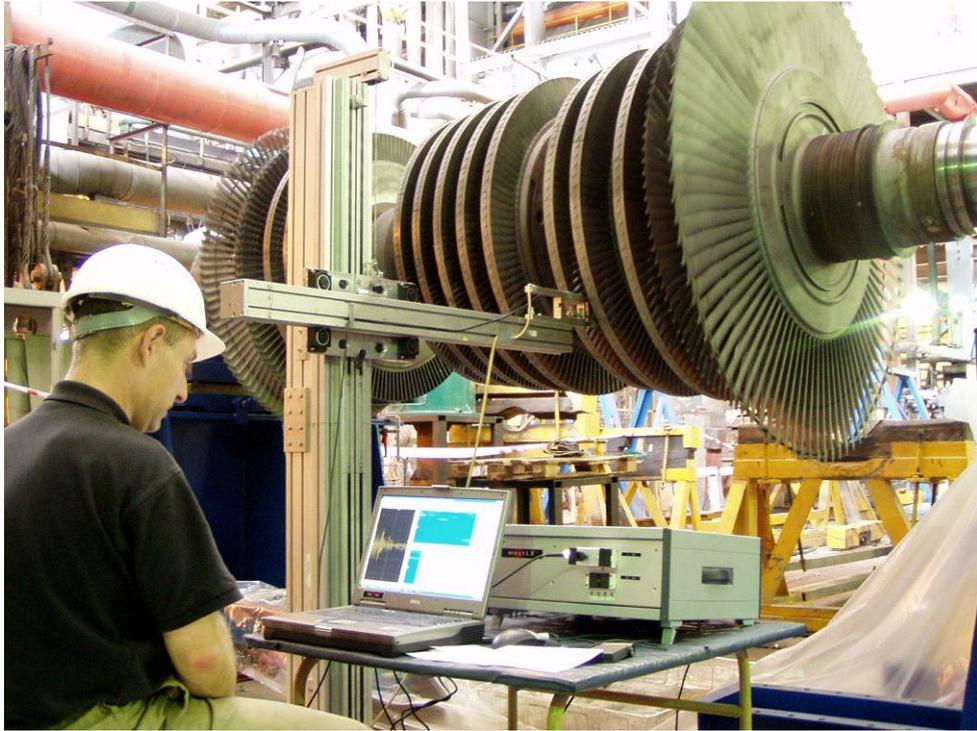
Fig. 8: Automated phased-array ultrasonic examination on blade attachment grooves in an HP/IP turbine shaft in Poland

The examination revealed indications in the area of anticipated defects in the blade groove of blade row No. 7. As the damage in an identical turbine shaft in 2004 could also be attributed to stress corrosion cracking in the blade groove of row 7, it was decided to remove the blades in the affected blade row and to perform conventional crack examination. This crack examination confirmed the indications detected by phased-array ultrasonic examination.

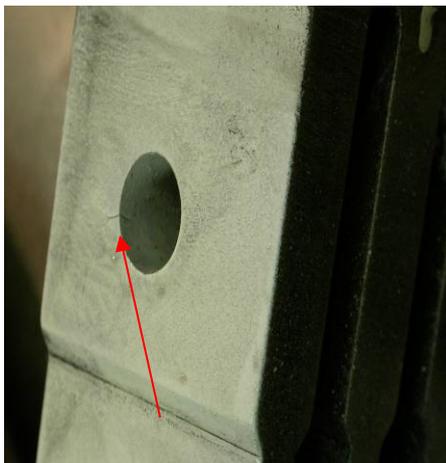
During operation of the turbine the area around the pin holes is loaded by very high stresses. Depending of the used pin design the pin holes of the blade roots prefer to crack at the upper pin hole. If such cracking will not be detected during scheduled inspection, a blade failure with heavy damages at the complete turbine can not be excluded. Because this it is important

Fig. 10 : Typically cracked radial entry pinned blade root
