RAIL RESTORATION LIFETIME ON HIGH SPEED LINE

Ph. Brédif¹, J. Plu², C. Royer², C. Poidevin¹ and Ph. Pouligny²

² SNCF, Track Design Department, 6, avenue François Mitterrand 93574 La Plaine Saint Denis, France

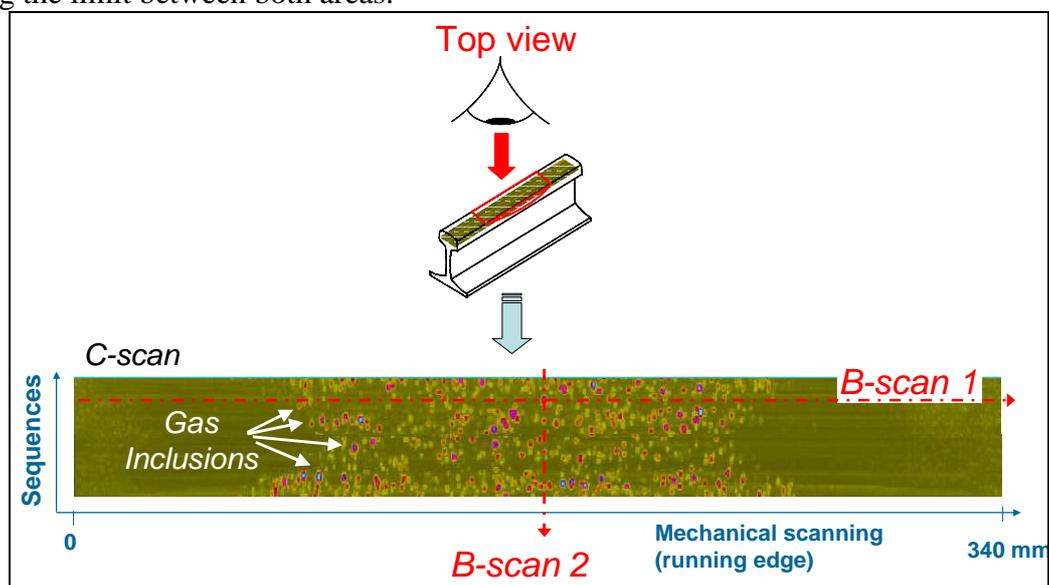
Figure 4. Example of inspection on track – Top view (C-scan)

Figure 4 to Figure 6 show an example of inspection obtained on track with the prototype. These three figures illustrate the possibility to represent data in various views as C-scan (top view), B-scan along the rail axis and B-scan in the plane perpendicular to the rail.

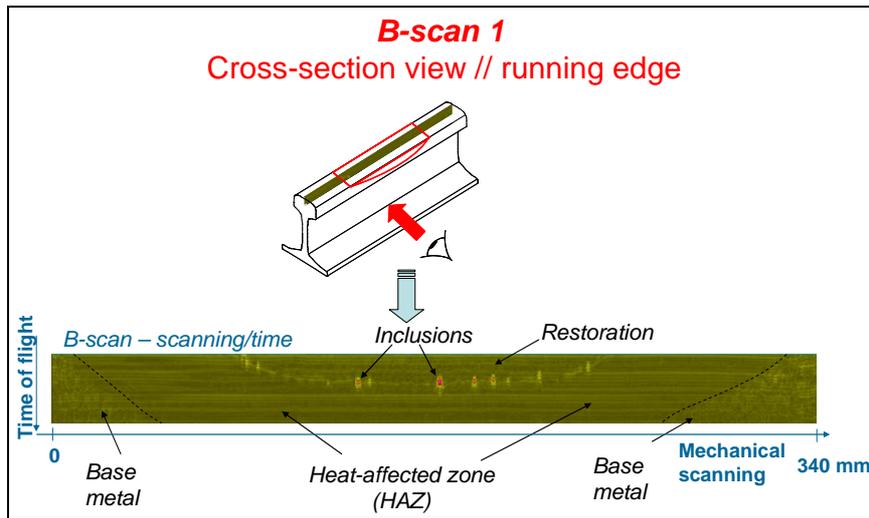
Figure 5. Example of inspection on track – Cross-section view // to the running edge (B-scan)

One can observe that gas inclusions are detected in the whole volume of the repair. On Figure 5, alignment of several defects marks the boundary between restoration and base metal. Moreover, a difference of structural noise between the HAZ (heat-affected zone) and the base metal allows separating the limit between both areas.

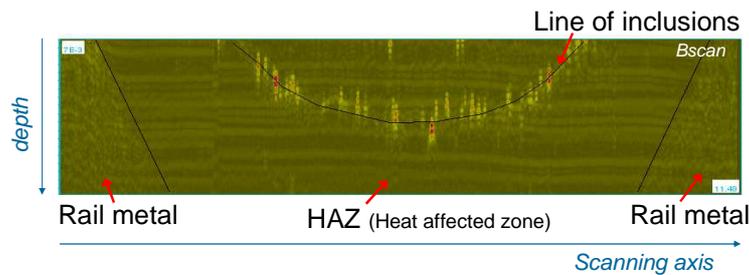
Figure 12. Line of inclusions

The localisation of porosities has a metallurgic explanation: welding operation involves fusion of the surface of the rail, and apparition of gas. UT observations show this alignment of gas inclusion.

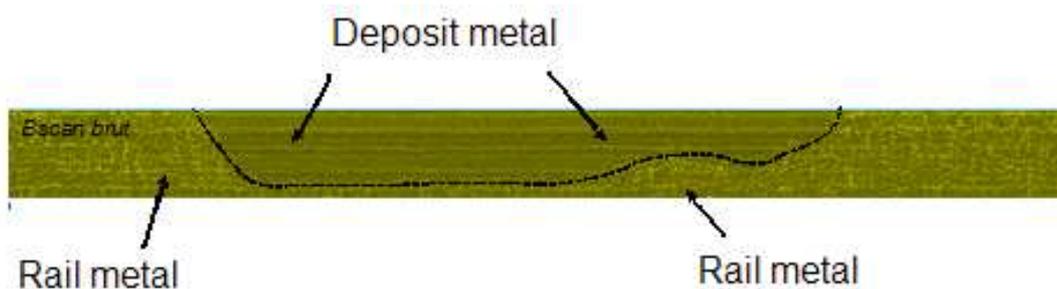
Figure 13: Limit of metals

- Depth of the deposit: It is possible to estimate the depth thanks to the visibly limit of rail metal/deposit metal by UT.

It is important to note that metal deposit thickness depends on age of restoration. Indeed, metal is removed by wear and grinding, especially on high speed line. After some years, metal deposit is totally removed. A first analysis made on the 370 restorations inspected during the campaign shows that only 20% are deeper than 5 mm.

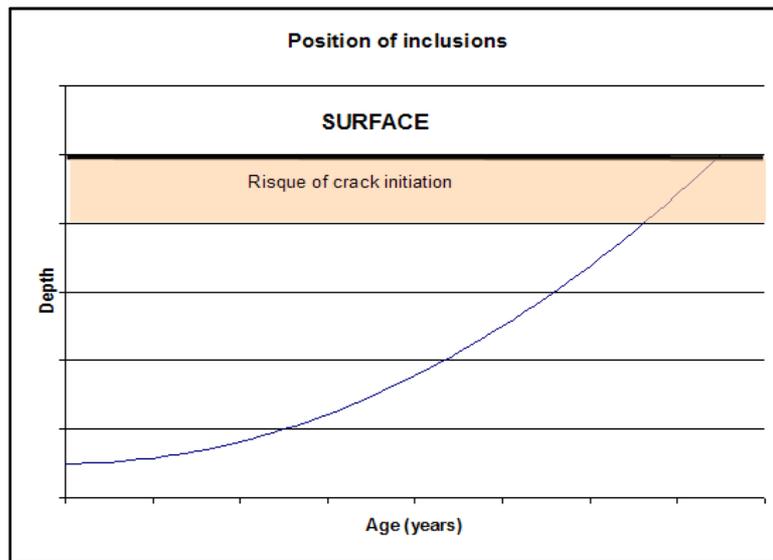
Figure 14: Risk area for crack initiation

- Location of inclusions in the metal deposit where risk of crack development exists

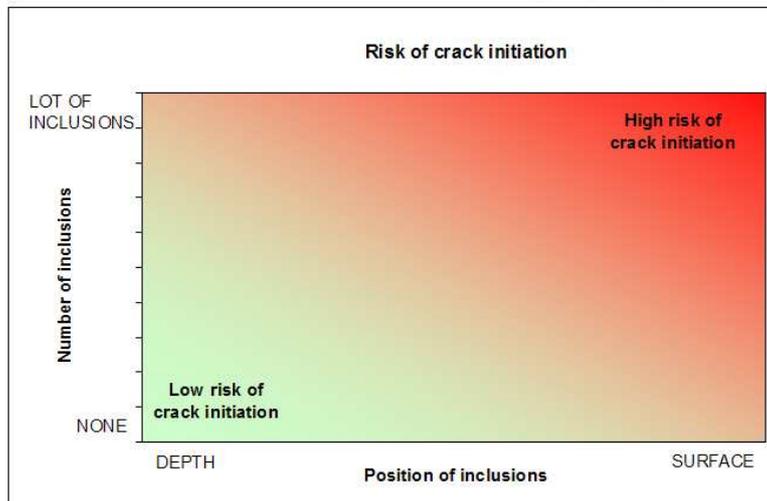
Figure 15: Risk of crack initiation

- risk of damage of rail restoration with initial metallurgic quality
