APPLICATION OF EDDY CURRENTS TO THE ESTIMATION OF CORROSION-FATIGUE DAMAGE

Michele SANGIRARDI, Michele CARBONI
Dept. of Mechanical Engineering, Politecnico di Milano
Via La Masa 34, I-20156 Milano, Italy

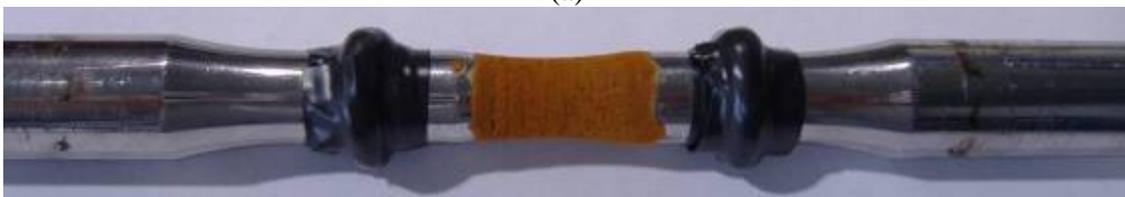
Figure 5 – Development of oxides (rust) during a corrosion-fatigue test.

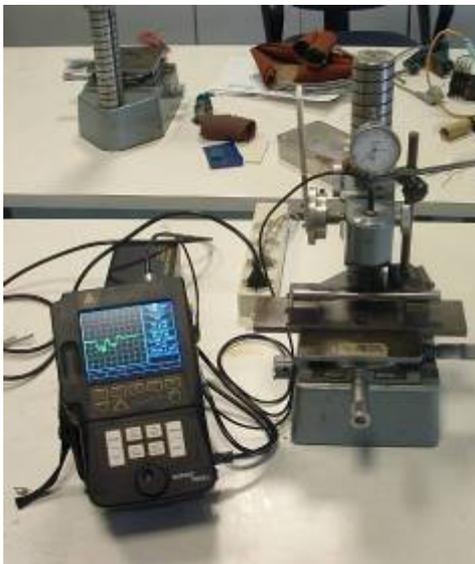
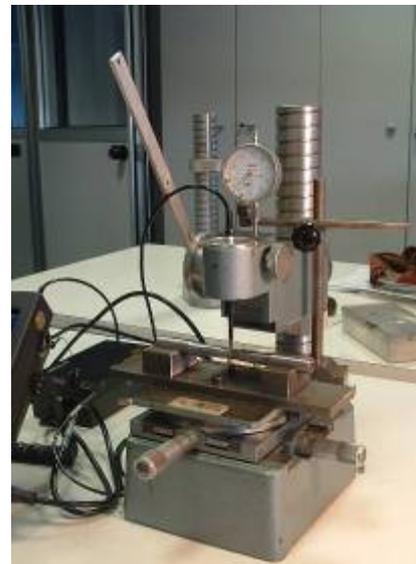
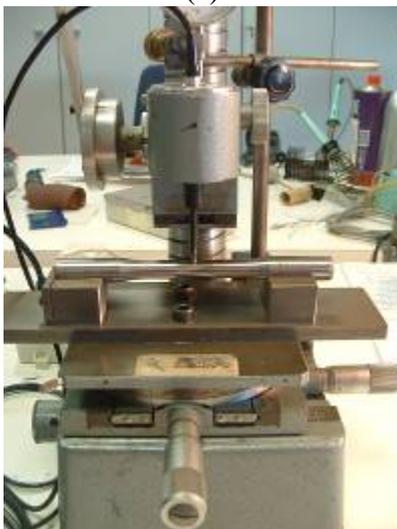
Figure 6 – Dedicated equipment for ET inspections of sample blocks.

ET inspections were carried out on sample blocks by means of a dedicated apparatus (Fig. 6a) expressly designed to control all the relevant parameters of ET inspections and to make repeatable measurements. In particular, a Nortec 1000S+ detector was adopted together with a differential probe able to work in the frequency range going from 500 kHz to 2 MHz. The frame of the equipment (Fig. 6b) is composed by a column and special V-wedges in order to guarantee the perpendicularity between the probe and the specimens, while a micrometric tablet is used to center the specimen below the probe (Fig. 6c). A centesimal comparator and a lever are used to exactly set the vertical position of the probe.

A special plastic wedge (Fig. 6d and 7) is applied to the probe. The need of such a wedge is due to the fact that the absolute position of the probe cannot be fixed during inspections since the profile of specimens changes with the developing corrosion-fatigue damage, while the chosen lift-off must remain the same. From this point of view, fixing the distance d (Fig. 7) by a screw, a fixed lift-off is guaranteed if the wedge itself is kept in contact with the specimen during the inspection. This condition was here satisfied adopting the weight of the probe as contact force. It can be added that the round section of the wedge realises also a better coupling with the hourglass shape of the specimen.

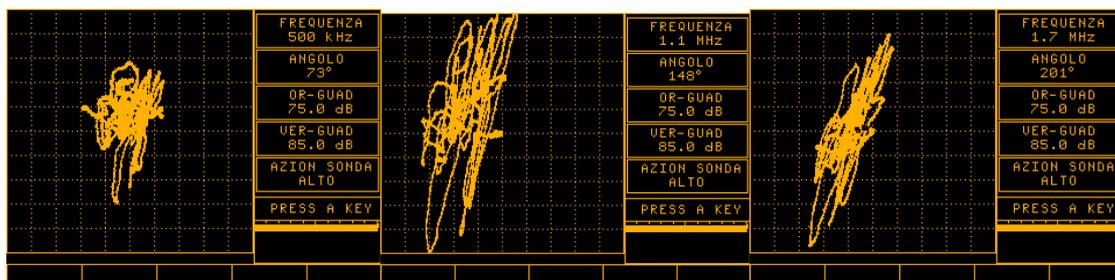
Figure 8 – Relationship between applied frequency and sensibility of the inspection: a) example polar responses for 500, 1100 and 1700 kHz; b) experimental trend.

The frequency for the inspection was chosen by means of a sensibility check carried out on one of the corroded specimens interrupted at 6×10^5 cycles. In particular, this specimen was inspected using the frequency values 500, 700, 900, 1100, 1300, 1500 and 1700 kHz (Fig. 8a shows the example of polar responses for 500, 1100 and 1700 kHz). It is interesting to note that the geometrical features of the polar response are maintained at different frequencies. The trend of the sensibility is reported in Figure 8b as a function of the adopted frequency. The higher sensitivity was observed in the range 900-1300 kHz, so all the inspections on corroded specimens were carried out at 900 kHz.
