QUANTIFICATION OF DAMAGE PROCESSES AT SURFACES AND INTERFACES OF BUILDING STRUCTURES USING OPTICAL METHODS AND ACTIVE THERMOGRAPHY

R. KRANKENHAGEN^a, M. RÖLLIG^a, Ch. MAIERHOFER^a, R. MECKE^b, M. SCHILLER^b, U. KALISCH^c, J. MEINHARDT^c, Ch. HENNEN^c

^aBAM FEDERAL INSTITUTE FOR MATERIALS RESEARCH AND TESTING, Berlin, Germany

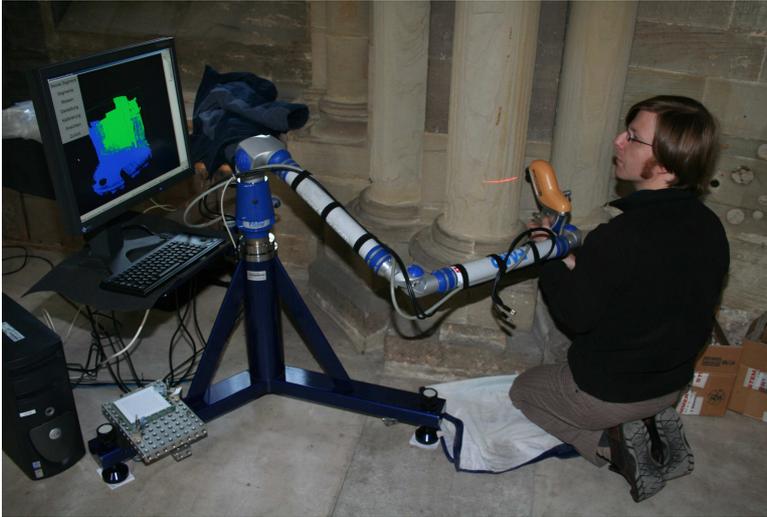
Figure 1: Light-section sensor with robot arm during the performance of measurements.

For the capture of the surface geometry of building surfaces and sculptures, a measuring system with two essential properties is necessary: The system should be suitable for a mobile application on the objects to be examined; and the data recording must be contactless. For the case studies described in the following, a light-section sensor developed at Fraunhofer IFF which is fastened to a measuring arm (figure 1) is used. The

sensor consists of a camera and a line laser. By applying integrated hardware-based image processing, the measuring system can detect up to 100 contour lines per second, with 1536 3D points each. Larger and complicated freeform surfaces can be covered. It is designed for flexible applications and can be used directly on the objects to be examined.

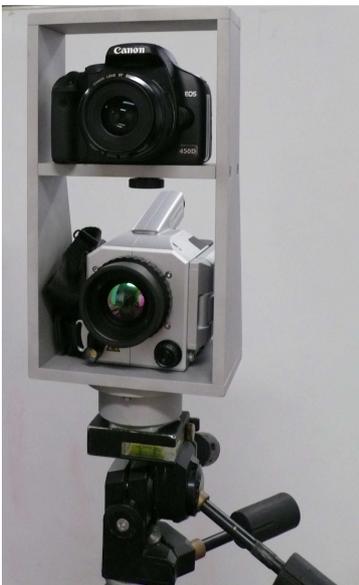
Figure 2: Frame for a stable connection between visual and IR camera.

The frame shown in figure 2 is a compromise: It consists of firmly screwed aluminium structure-profiles. The fixation of both cameras occurs in each case with a screw from below. This screw is positioned inside a precise borehole. In addition, for every camera a stop position is realized by a pin. With it the position of every camera is fixed unambiguously. The operability of the IR camera is limited a little bit, because the display cannot be opened out, only the view-finder is accessible. But as a notebook is

used for data acquisition, this limitation is not relevant. For recording of similar image sections, an objective with short focal distance length is used for the visual camera. Then, the visual image contains the whole image of the IR camera as a section.

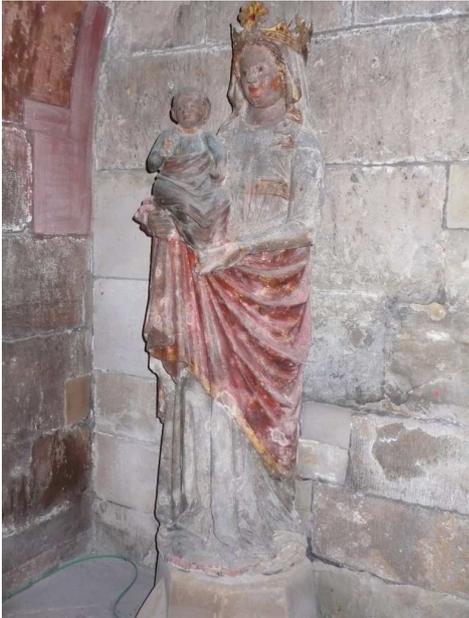
Figure 5: Madonna with child in the dome of Halberstadt

The Madonna with child in the chapel of Virgin Mary of the dome of Halberstadt was created in 1270/1280 (see figure 5). It consists of shell limestone from Halberstadt. The surface is covered with a polychrome rim. Originally, there have been several damages like various efflorescences, softening of limestone, sanding, derogations and faults, a strong damaged rim, blowy bulging and dirt. These damages have been the cause for restoration and preservation measures. The last restoration was carried out in 2004 under the specification of smallest possible intervention. The
