# ACOUSTIC EMISSION SIGNAL PROPAGATION THROUGH WELDED STEEL BRIDGE JOINTS

Małgorzata KALICKA

INSTITUTE OF STRUCTURAL ENGINEERING, ETH Zurich  
8093 Zurich, Switzerland  
kalicka@ibk.baug.ethz.ch

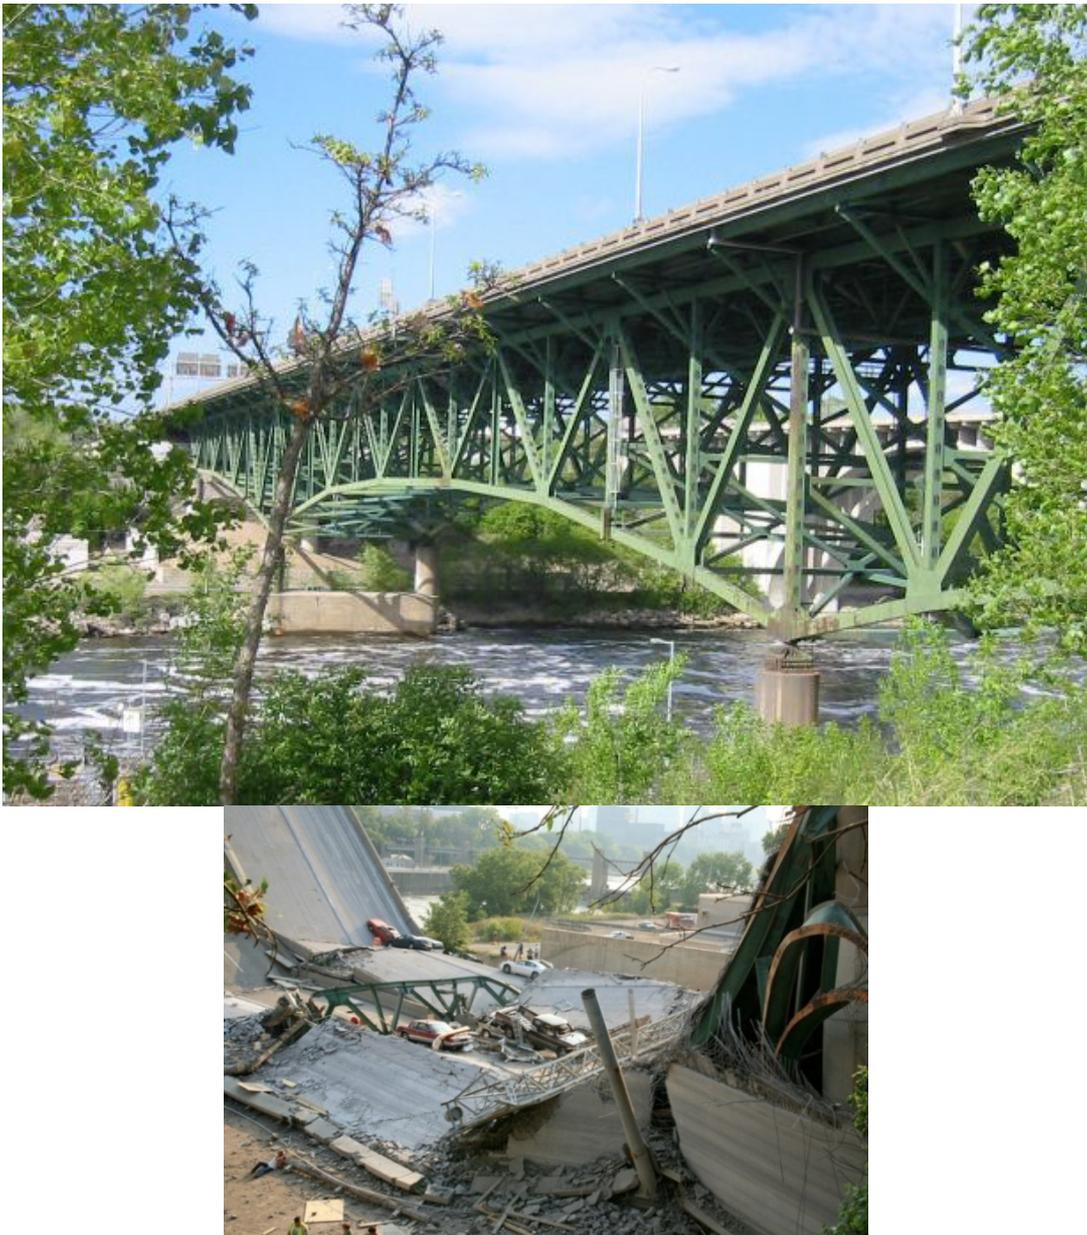
Figure 1: I-35W Bridge over The Mississippi River, USA: (left) before [3] and (right) after the collapse [4] courtesy to Mr. Tim Davis, Consolidated Photo, USA.

During the last years, some structural failures have concerned the public's and government's opinion. The first example is the collapse of the I-35W steel bridge over the Mississippi River in Minneapolis, USA in 1<sup>st</sup> of August 2007 (see Figure 1). National Transportation Safety Board (NTSB) identified a design flaw as the likely cause of the collapse, and asserted that additional weight on the bridge at the time of the collapse triggered the failure [1]. The second example is the collapse of the trade steel hall in Katowice, Poland in 28<sup>th</sup> of January 2006. The collapse of the hall, which took place during an exhibition of pigeons, occurred due to poor design and snow load exceeding the design value. Both of these failures were sudden and unexpected. Could these tragic events, where many people died or were injured, be avoided? The solution for sudden failures/collapses is to develop a warning system, which could detect critical destructive events early enough and could automatically forward notices to responsible bodies, as well as to structure users. The necessity of developing warning monitoring systems against failure has been highlighted by responsible authorities around the world. The clear directions to equip civil engineering structures with continuous monitoring systems have been established, of which the decree of the Moscow City Mayor is an example [2].

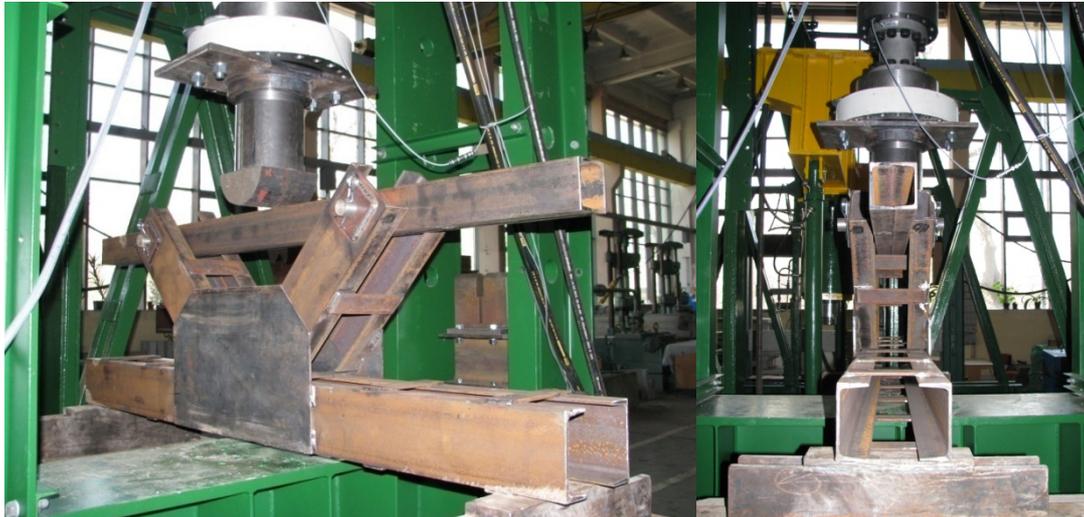
Figure 2: Full scale model of a steel bridge joint.

The experiments presented in this paper have been undertaken in the Laboratory of Strength of Materials at the Kielce University of Technology in Poland while the analysis of the results has been performed at the ETH Zurich in Switzerland. The signals propagation has been analysed in a full scale model of a spatial steel bridge joint (see Figure 2 and Figure 3).

The DECI SE55-R, characterized by low frequency and high sensitivity at 55 kHz (see Figure 4) were chosen for monitoring of the steel bridge joint because of their low signal damping [11]. For the experiment, six sensors of this type were mounted symmetrically on the bridge joint (see Figure 2, 3, 5) i.e. three on Plane 1 (front) and three placed symmetrically on the Plane 2 (back).

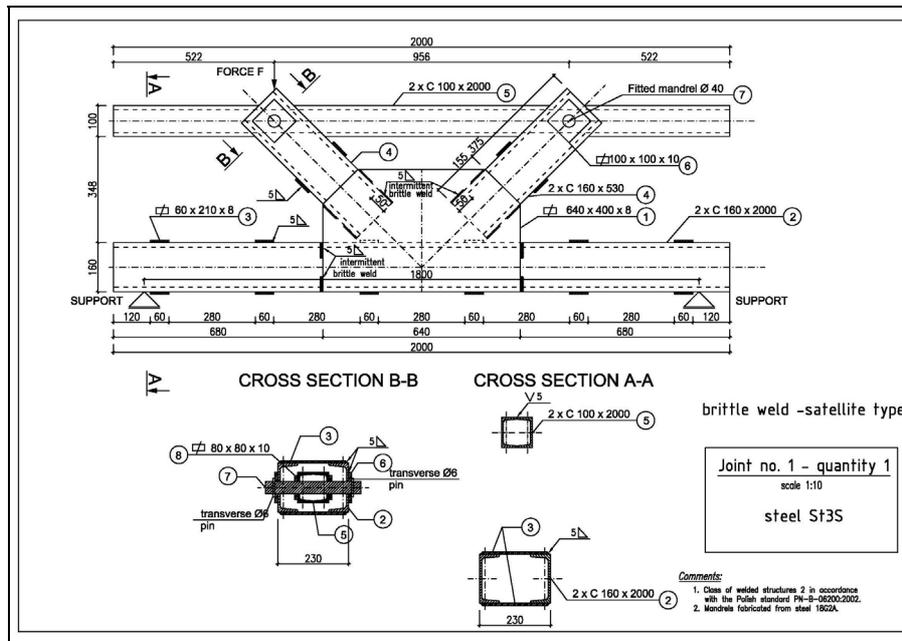
The bridge joint contain a two-plane truss (front and back) assembled of parallel steel profiles (lower band 2xC 160x2000, upper band 2xC 100x2000, cross band 2xC 160x530 and joint plate 640x400x8) connected by welded braces (steel plates 60x210x8 mm). To obtain the desired “clear” AE signals, the set of reference pencil mine breaks have been performed at previously selected points on the front plane of the joint. These points are marked as triangles in Figure 4 (MB1, MB2 and MB3). Each set of mine breaks (MB) consisted of ten single events. For comparison, each MB was repeated several times. Normally, the average amplitude of a mine break varies between 90 and 95 dB. These AE signals are short and produce high energy, which corresponds to the AE signals generation during an initiation of brittle cracking of welded truss joints.

Figure 3: Geometry of the steel bridge joint.

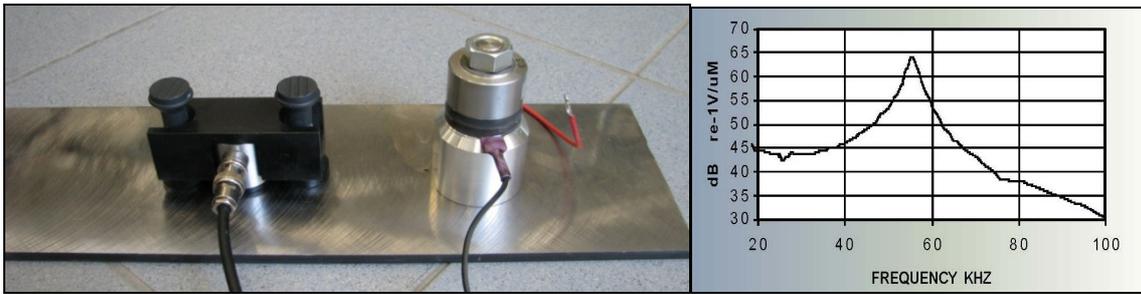
Figure 4: (left) DECI SE55-R sensor and Langevin's probe type HEC-45282; (right) SE55-R characteristic frequency response.

The reference signal source was Langevin's probe type HEC-45282 (Figure 4).

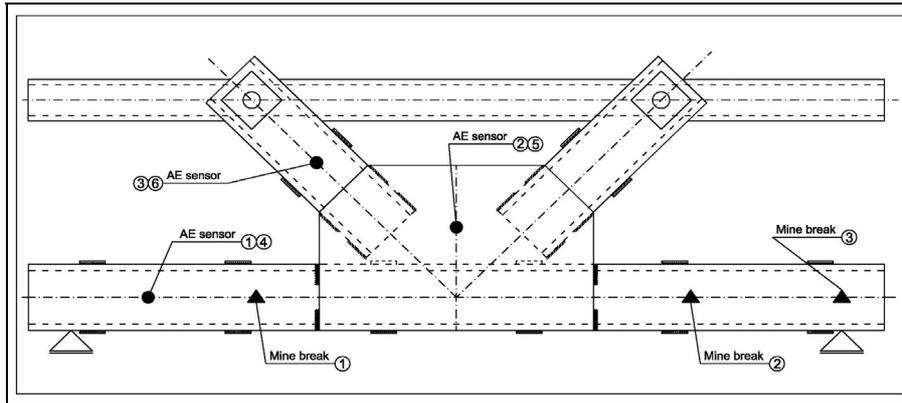
Figure 5: Scheme of distribution of AE sensors on the joint. Triangles indicate the mine break points.

The pencil mine breaks served as AE reference source signals. Each set of mine breaks (MB – see triangles MB1, MB2 and MB3 in Figure 5) consisted of ten single events and was repeated several times for comparison. AE signals generated by the reference MBs in plane P1 have been registered by all of the AE sensors (Channels CH-1 – CH-6), localized on both planes P1 and P2. The transformation of the AE signals through the welds and the lacings resulted in a change of the signal shape and value of AE parameters i.e. loss of energy and amplitude (see Figure 6), where the differences reached 15 dB up to 30 dB. The level of loss depends on the position of the reference source and the receiver. Only a small number of hits reached a high level of amplitude. Most of the recorded AE signals exhibit a long duration i.e. three times longer and maintain a low amplitude (see Figure 7, 8 (right)). The character of these signals is showing some similarities to continuous signals i.e. noise and fatigue or corrosion processes. In case of analysing of unknown and not localized sources, this phenomenon could be easily misinterpreted and classified as a different process.

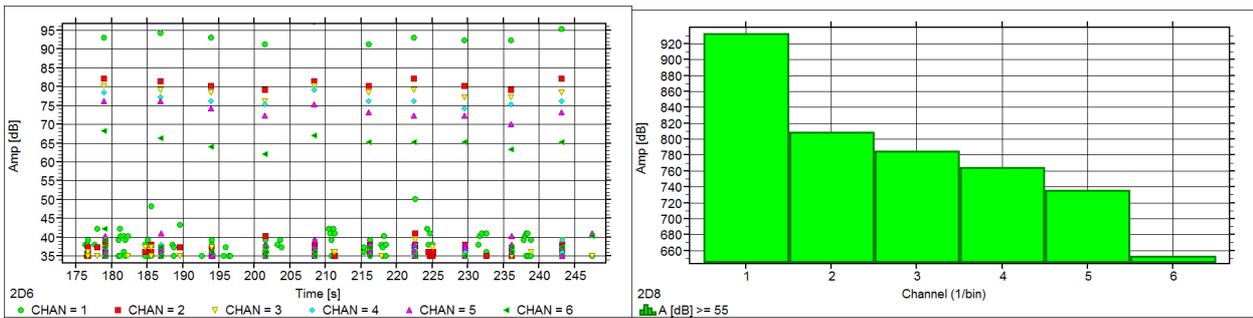
Figure 6: MB1: AE activity during 10 mine breaks; (left) amplitude vs. time correlation diagram, (right) bar distribution summary of amplitudes above 55dB in separate channels.

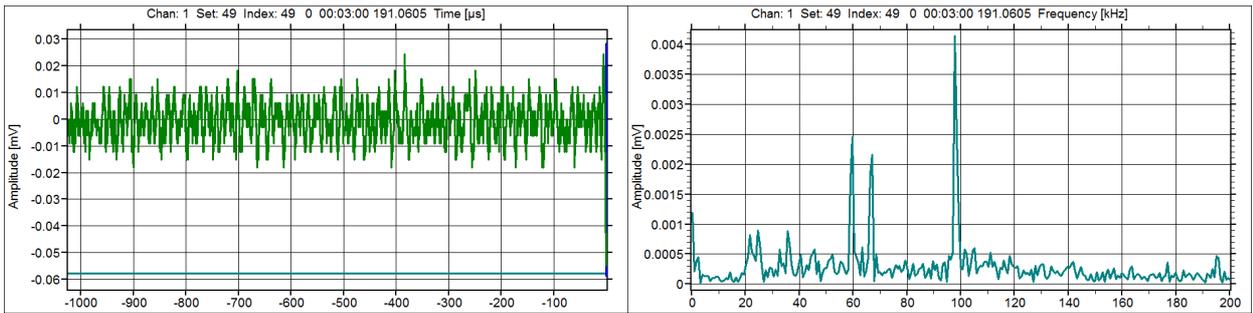
Figure 7: MB1 P1: Waveforms of a single mine break at high amplitudes in channel 1: (left) Sample signal, (right) FFT.

The variation of signals' pattern and parameters at the low energy level is to be investigated in the complicated structural form. The characteristics of the material itself allow continuous reflections, signals interference and overlapping. The Fast Fourier Transformation (FFT) of the AE signals taken from both planes has revealed hardly any divergences in signal patterns (see Figure 7, 8 (left)). In both presented signal examples (CH-1 and CH-5), there are visible low amplitude peaks at different frequencies despite the fact that only one type of resonant sensors with characteristic peak at 55 dB has been applied.

This type of signals does not provide any straight forward information about the destructive processes, which are dangerous for the structural integrity. Due to the multiple signal reflections and interferences, the registered waveforms' patterns are modified and it is difficult or even impossible to distinguish the primary signal parameters characterizing the clear sources i.e. destructive processes. Among the registered signals, only a few sample waveforms could be recognized as "references" (see Figure 9, 10) and could refer to the dangerous processes. Their amplitude is estimated to be between 50 and 95 dB and their duration is relatively short. The unexpected is the high amplitude at the frequency of 20 kHz in the FFT analysis, which still needs to be further studied.

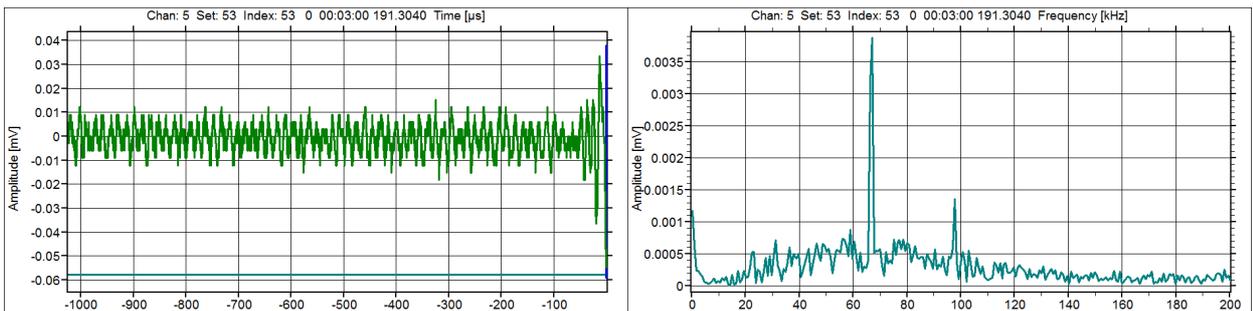
Figure 8: MB1 P2: Waveforms of a single mine break at high amplitudes in channel 5: (left) Sample signal, (right) FFT.

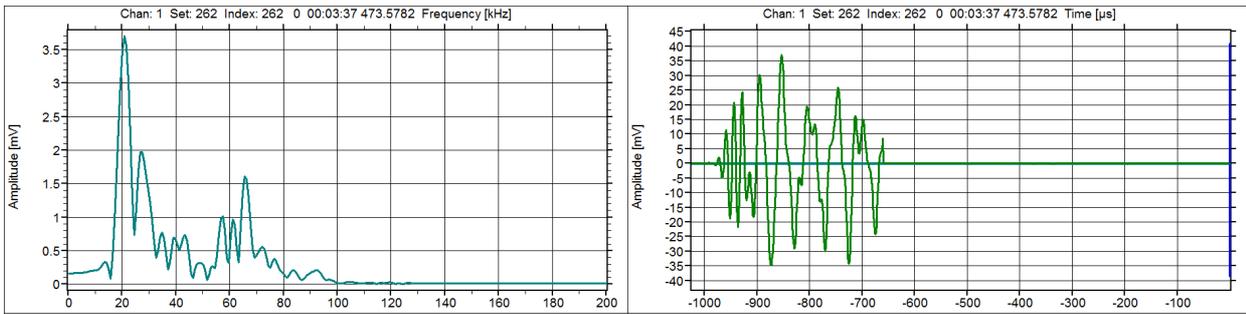
Figure 9: MB1 P1: Waveforms of a single mine break at low amplitudes in channel 1: (left) FFT, (right) Sample signal.

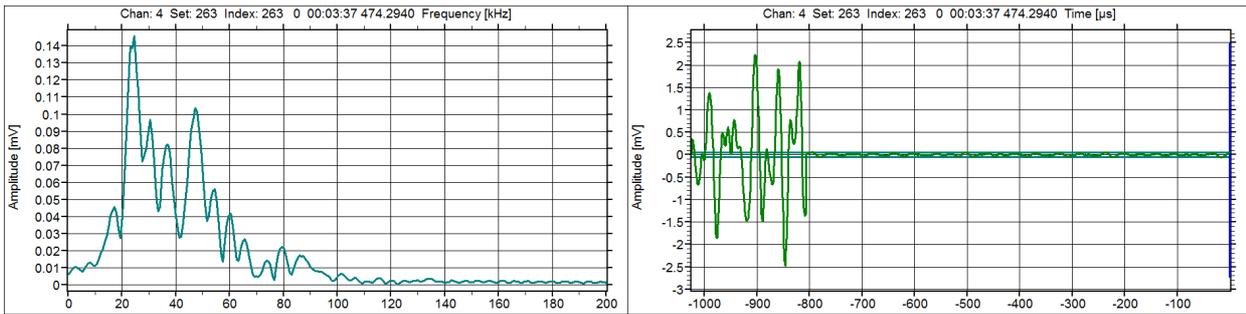
Figure 10: MB1 P2: Waveforms of a single mine break at low amplitudes in channel 4: (left) FFT, (right) Sample signal.
