Advanced Ultrasonic application for the inspection of turbine components

Hans RAUSCHENBACH,
Michael CLOSSEN- VON LANKEN SCHULZ,
Dr. Michael OPHEYS, Michael SIEGEL, Siemens Energy Sector

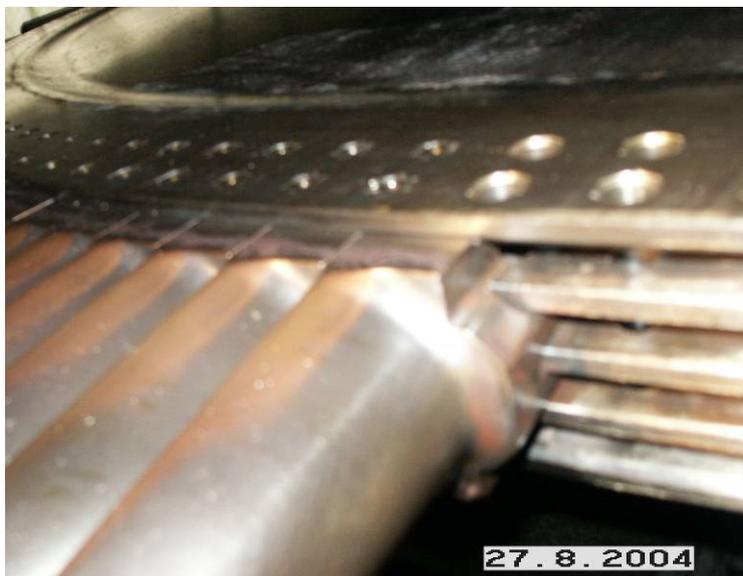
Fig. 9: LP Turbine rotor with radial entry pinned blade roots

During operation of the turbine the area around the pin holes is loaded by very high stresses. Depending of the used pin design the pin holes of the blade roots prefer to crack at the upper pin hole. If such cracking will not be detected during scheduled inspection, a blade failure with heavy damages at the complete turbine can not be excluded. Because this it is important
