RAIL RESTORATION LIFETIME ON HIGH SPEED LINE

Ph. Brédif¹, J. Plu², C. Royer², C. Poidevin¹ and Ph. Pouligny²

² SNCF, Track Design Department, 6, avenue François Mitterrand 93574 La Plaine Saint Denis, France

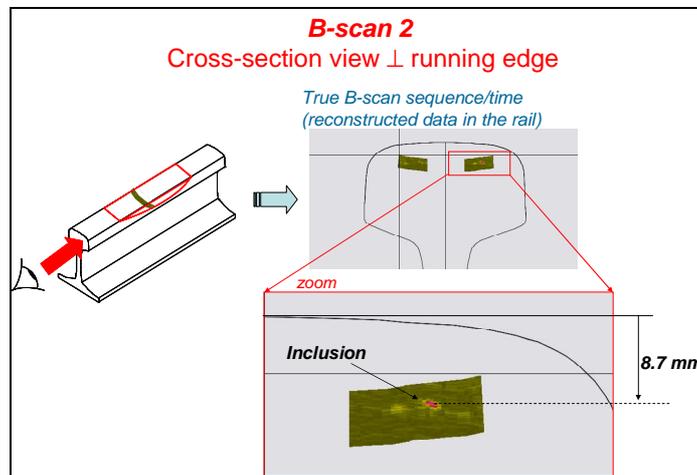
Figure 6. Example of inspection on track – Cross-section view \perp to the running edge (B-scan)

One can observe that gas inclusions are detected in the whole volume of the repair. On Figure 5, alignment of several defects marks the boundary between restoration and base metal. Moreover, a difference of structural noise between the HAZ (heat-affected zone) and the base metal allows separating the limit between both areas.

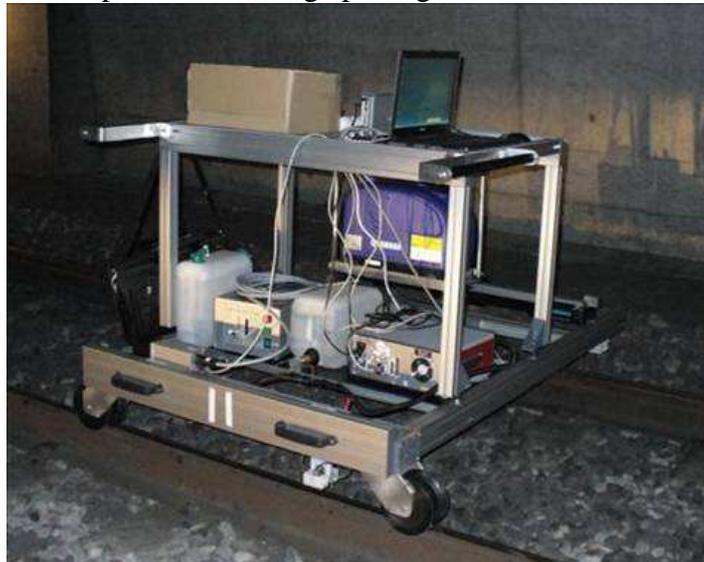
Figure 11 : On track inspection

Nine rail restorations were inspected on average per night, so around 370 results.
