APPLICATION OF THE BRAGG GRATING OPTICAL SENSORS AND EDDY CURRENT METHOD FOR THE NON DESTRUCTIVE TESTING OF BONDED COMPOSITE REPAIRS

G. Tsamasphyros^a, G. Kanderakis^a, P. Vouthounis^b, I. Prassianakis^a

Keywords: Bonded Composite Repair, Bragg Gratings, Eddy-Current, Non Destructive Testing.

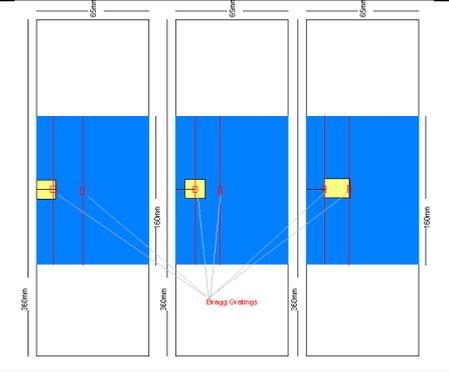
Table I: Material properties and basic specimen's geometry

Additional specimens were manufactured in order to study potential adhesive debonding propagation (Type II specimens). Each of these specimens was representing a potential debonding (yellow area in picture included in Table II) developed in the area of the crack tip, between the composite patch and the repaired metallic area. The aim of the test series was to examine the possible propagation patterns of the cracked and/or debonding area, using NDI techniques. The specimens, manufactured using Table II materials with six ply composite patch, were submitted to fatigue testing at Mean load 2.1 tn, Amplitude 1,9 tn and Load frequency of 10 Hz. Finally, in order to monitor the propagation of a crack in a composite patch repair, more specimens were manufactured, having two embedded optical fiber sensors (Type Iii specimens). The crack tip sensor was called as sensor “a” while the second sensor was called “b”. The loading conditions of the specimens were identical with the previous ones. The data acquisition during the fatigue loading of these specimens included measurement of crack length at 10K cycles and every 2.5K cycles with simultaneous sensor wavelength shift recording, measurement of debond area using C-Scan NDI every 10K cycles and ramp type tensile loading every 10K cycles with simultaneous sensor wavelength shift recording

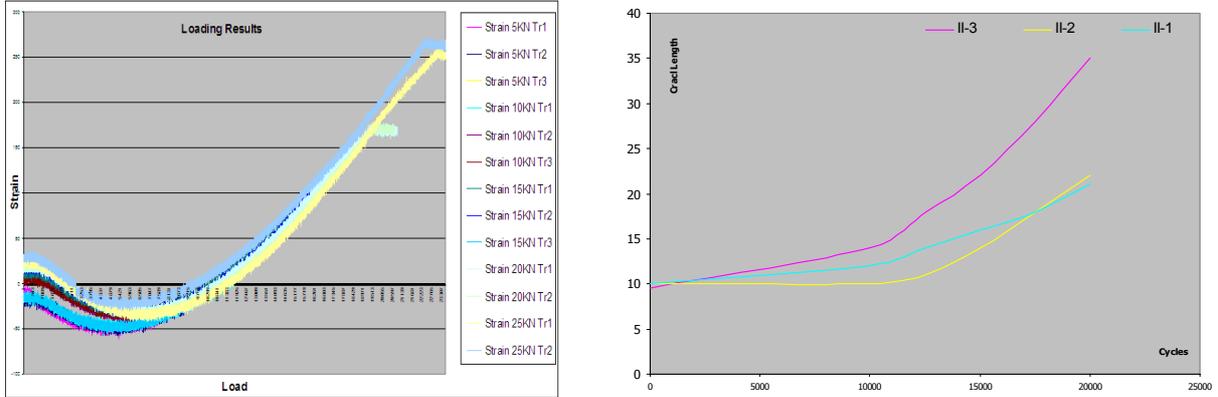
Figure 1: Load vs. Strain results during repeatability test (left) and crack extension of specimens Type II (right)

The results of the tensile loading of specimens type I are presented in the left part of Figure 1. It is shown that the repeatability of measurements is very satisfying and the strain measuring capability of the sensor is accurate, therefore the sensors were considered appropriate for the experiment.

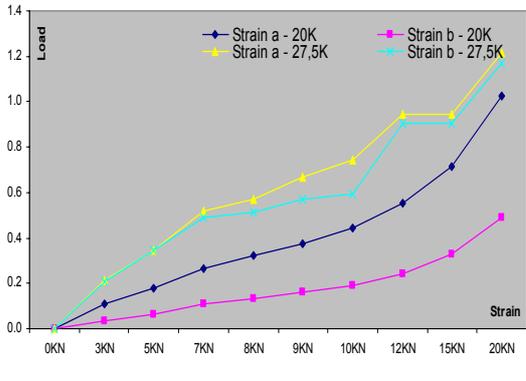
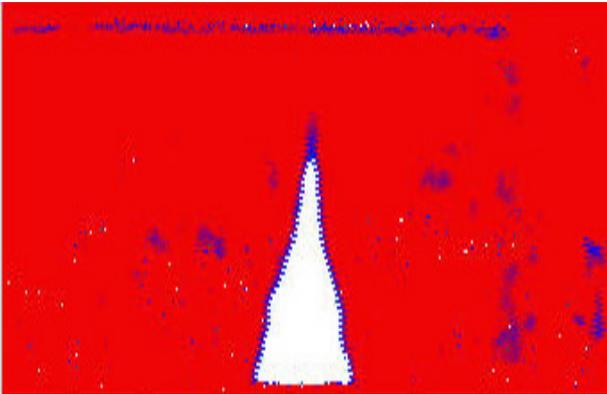
Figure 2: Debonding extension monitoring and final debonding area for specimens Type III.

It was also found that during the initial tensile loading, compressive loads are developed near the crack tip, due to the fact that the specimen has a resulted curvature from the curing process because of the thermal coefficient mismatch of the patch and the aluminum material. Representative results of the specimen type II loading, with respect to crack extension, are presented in the right part of Figure 1. Moreover, C-Scan NDI was performed on these specimens in order to check the debond propagation due to the fatigue loading. Various results were taken from the fiber optic sensors during the testing of specimens type III. The results are split in two major categories: results related to the debond extension and results related to the crack propagation. Some representative results concerning bond extension monitoring, are presented in Figure 2. From the above results it is obvious that, during the ramp loading, there is a shift in strain measurement due to the fact that the debond has propagated and resulted in a field alternation near the fiber optic sensors.

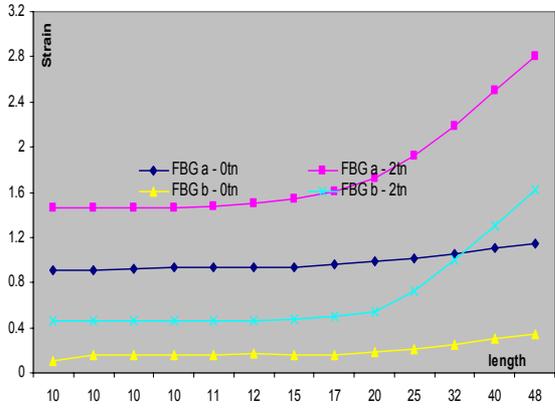
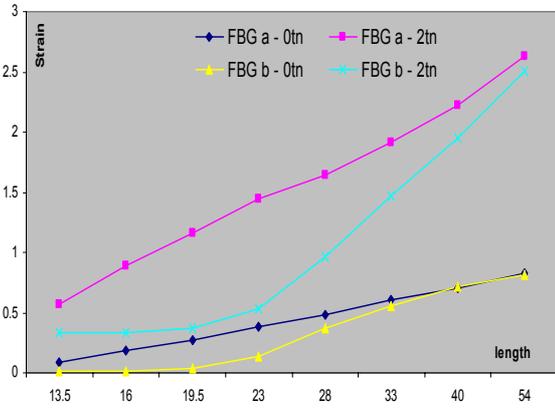
Figure 3: Representative crack propagation monitoring results

Some representative results concerning the crack propagation monitoring, are presented in Figure 3. From the above results, a strain increment is obvious during the crack propagation. Moreover, for the sensor “b” of each specimen, a sudden strain increment was noticed when the crack was passing through the vertical level of the sensor. Moreover, according to further processing of the results, it was noticed that during the crack propagation and when the crack “passes” from the sensor “b”, the increment curves of the two sensors cross each other, giving a notion of the crack length on that time. More details on the experimental process followed together with analytical results can be found in [12].

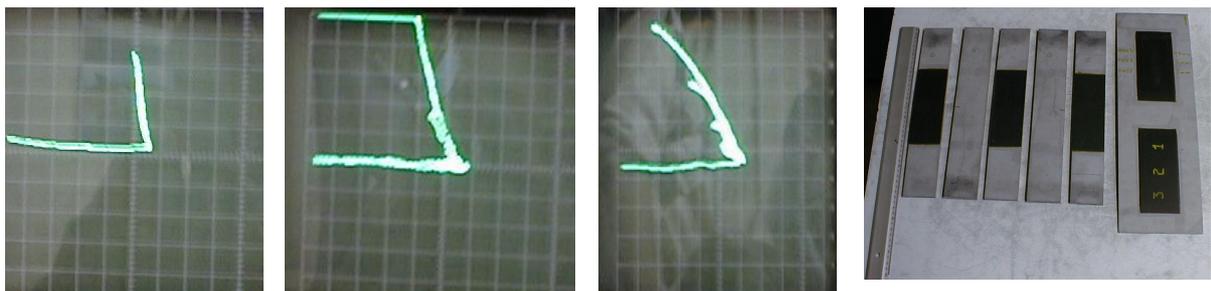
Figure 4: *Waveform produced by the crack measured at the unpatched (1st photo) and the patched side (2nd photo) measured above the boron patch. Waveform produced by the three different cracks (0.5mm, 1mm and 2mm) above the boron patch of the calibration specimen (3rd photo). Specimens manufactured and calibration specimen (4th photo)*

using an angle of 283° , Gain=48 (24dB), Filter=0, Vsensitivity=0.2 and Hsensitivity=1. The waveform produced because of the cracks is shown in Figure 4, while the measured crack lengths are presented in Table II. The calibration of the instrument for the NDI above the boron patch was achieved by using a patched aluminum plate with cracks of known length under it. The produced waveform for the different crack lengths (0.5mm, 1mm and 2mm) is shown in the 3rd picture of Figure 4. The angle varied according to the number of layers of the patch (226° for 2 layers, 223° for 4 layers and 219° for 7 layers) while the rest of the parameters were kept to their original values.

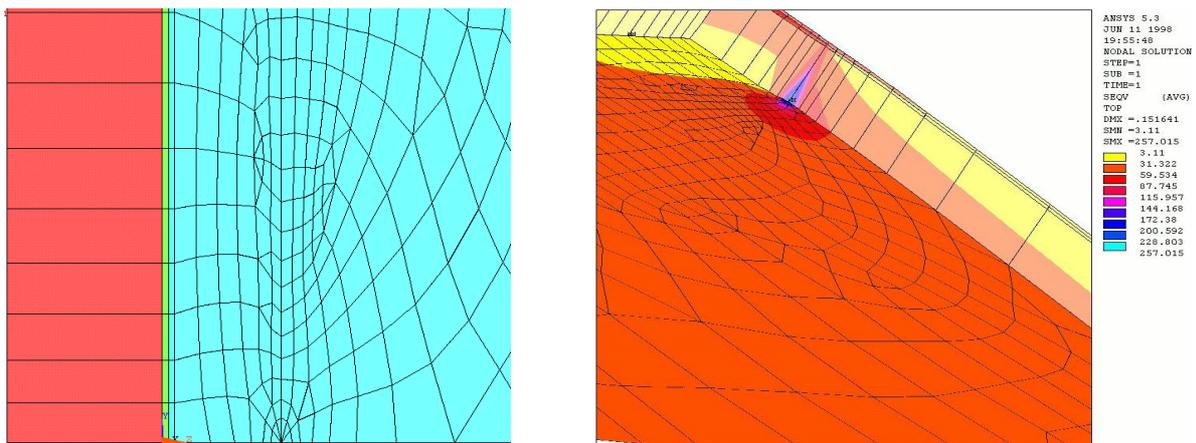
Figure 5: Detail of the different layers and the crack area (left) and qualitative FEA results explaining the difference in the crack propagation rates between the unpatched and the patched side of the specimen.

The crack lengths measured above the patch were compared with the corresponding crack lengths measured from the non-patched side of the specimen. As obviously shown in Table II, the crack lengths at the unpatched side were slightly higher than the ones measured at the patched side. Again, this was predicted from the finite elements analysis, by the different values of the stress intensity factor at the two sides of the specimen, which resulted in different crack propagation rates. In Figure 5 a detail of the mesh in the crack area is presented together with some FEA results, which provide a qualitative explanation concerning the difference in the crack propagation rates between the unpatched and the patched side of the specimen. More details on the experimental process followed together with analytical results can be found in [7].
